Demonstration/Validation for Federal Specification MMM-A-121 Hazardous Air Pollutant-Free Adhesive Replacement

ARL-TR-5502 April 2011

Army Research Laboratory

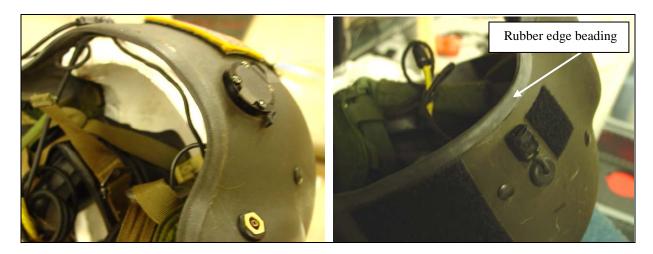
Figure 2. HGU-56/P aviation helmet without beading (left) and with beading (right).

The edge beading repair adhesive performance characteristics were required to be equal to or better than the baseline. The helmets were evaluated by the inspector for blistering, edge lifting, deterioration of adhesive, or failure of the adhesive bond (12). The evaluations were conducted at the time of application—24 h, 90 days, and 180 days after the initial application (appendix A). Technicians evaluated the ease of adhesive application and performance of initial bonding relative to the baseline at the time of initial application. The technician commented that the initial application of the 3M-847 adhesive was slightly harder to work with compared to the

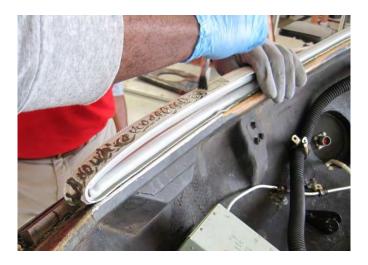
Figure 14. Baseline (3M-1357) adhesive application to UH-60 NDS.

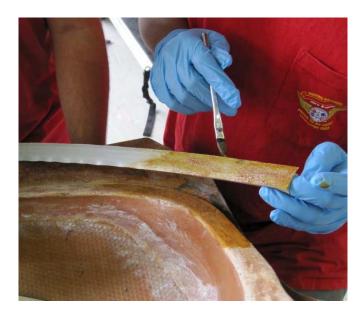
Figure 15. Alternative (3M-847) adhesive application to UH-60 NDS.

both of which contributed to the difficulty in spreading the material evenly. Overall, the team stated the alternative adhesive (3M-847) appeared to perform well but was slightly more difficult to apply than the baseline (3M-1357).

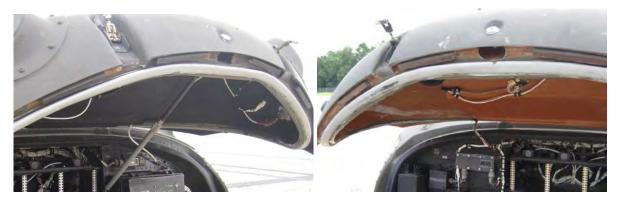
After the adhesive application, the nose doors were reinstalled on the aircraft (figure 16) and released into the field for normal operation. Inspections were conducted at 24 h, 7 days, 30 days, and 90 days after application to determine how the adhesives performed over time (appendix B). In each inspection, the alternative adhesive did not show any signs of slippage, delamination,

blistering, deterioration, or failure compared to the baseline (appendix B). The photos in figure 16 show the two UH-60 helicopters after 90 days in the field. The helicopters were photographed intentionally with the nose door open to view the condition of the NDS. At the end of the 90 day field trial, both NDS's were still properly adhered to the respective UH-60 nose door. Overall, the inspector concluded that the alternative adhesive (3M-847) performed as well as the baseline (3M-1357).

Figure 16. UH-60 NDS after 90 days in the field, baseline (left) and alternate (right).

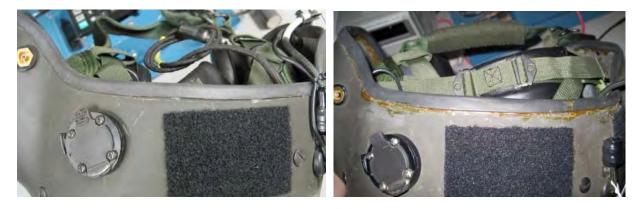
Figure 17. Aviation helmet after adhesive application, baseline (left) and alternate (right).

Inspections were conducted at 24 h, 90 days, and 180 days after adhesive application to determine how the products performed over time (appendix B). In each inspection, the alternative adhesive did not show any signs of slippage, delamination, blistering, deterioration, or failure, except for a slight lifting in the curved areas (appendix B). This lifting appeared to be caused by the fast drying time during application rather than failure of the adhesive over time (figure 18). Overall, the inspector concluded that the alternative adhesive (3M-847) worked as well as the baseline (E-1293) if the quick drying time was considered in the application process.
